**Olin Corporation**

**RE: Results of Containment Area Bedrock Borings  
Olin Chemical Superfund Site (OCSS)  
Wilmington, MA**

**Subject: Containment Area Bedrock Boring Results, Olin Chemical Superfund Site (OCSS) in Wilmington MA (Site)**

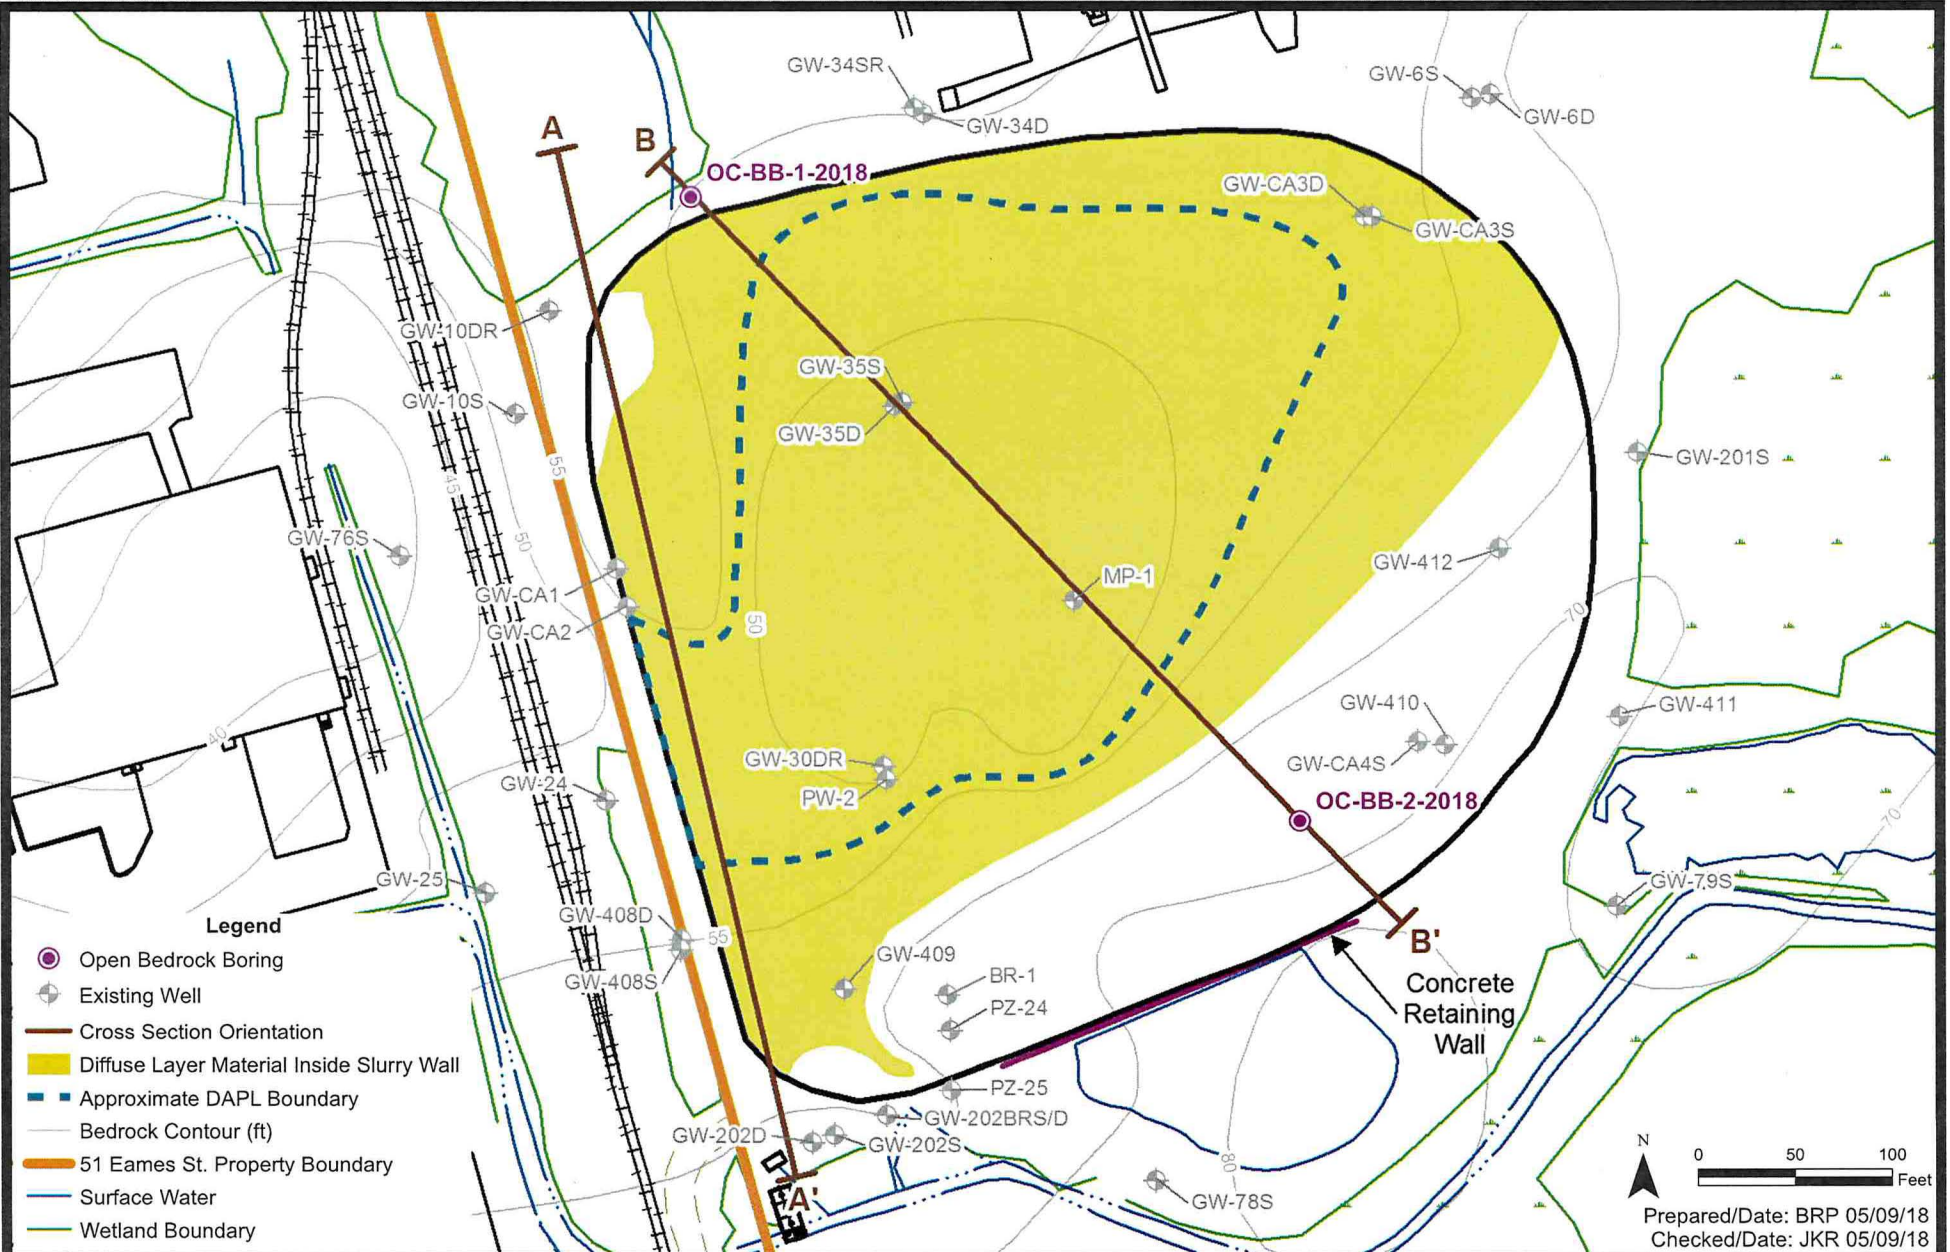
Figure 1  
Location of Borings and Cross Sections  
Containment Area

Drilling activities were started at OC-BB-2-2018 on March 21, 2018. As shown in **Figure 1**, the drilling location is inside the Containment Area and immediately adjacent to the associated DAPL pool. Truck mats were placed on

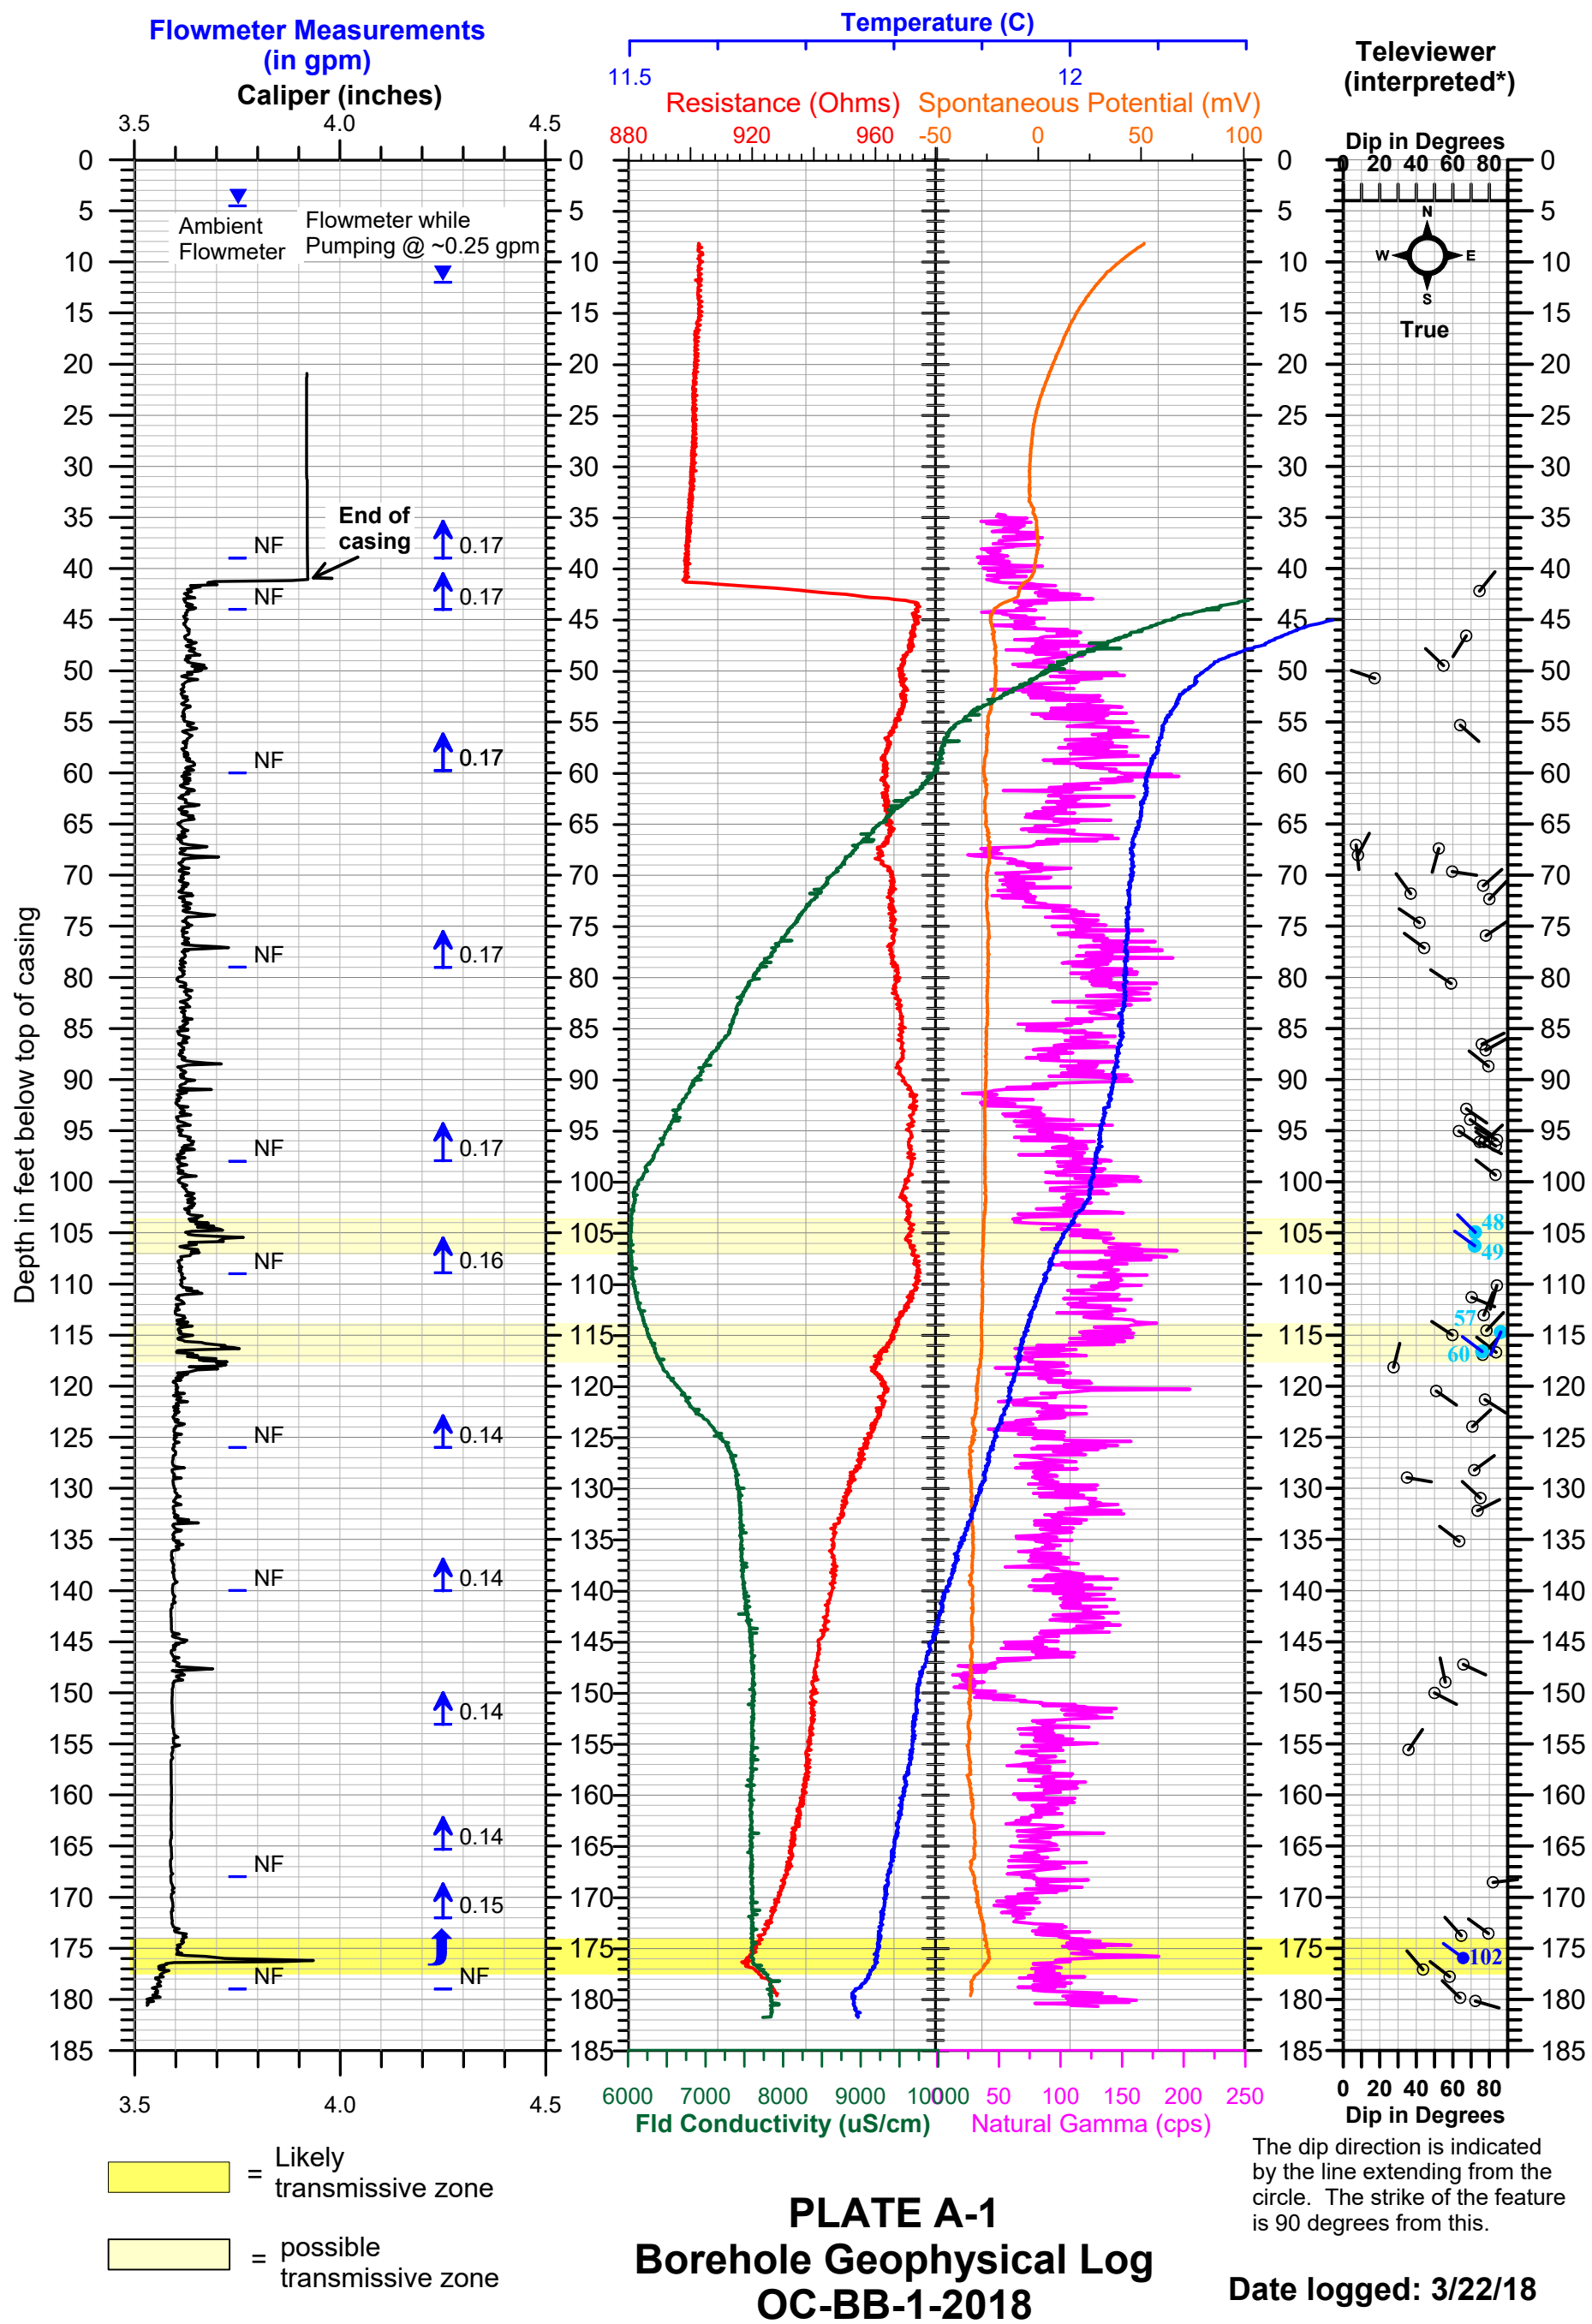
PLATE A-1  
Borehole Geophysical Log  
OC-BB-1-2018  
Olin Site  
Wilmington, MA.

The borehole geophysical results at OC-BB-1-2018 indicated a water bearing (likely transmissive) fracture at approximately 175 feet bgs. This is supported by a large caliper deviation, an ATV amplitude signature and a visual indication of a fracture on the OTV log in addition to positive identification in the heat pulse flow meter (HPFM) testing and inflections in the temperature, fluid conductivity, spontaneous potential and resistance logs. HPFM data suggests a possible (very) small increase to borehole flow at 115-118 feet and 105 feet bgs (possible transmissive zones) associated with small caliper deviations, a small resistance inflection at 118 feet and a gradual change in fluid conductivity at 105 feet. The presence of transmissive fracture at these intervals is not well corroborated by the ATV and OTV logs or other logs. Overall these features indicate the potential presence of weakly transmissive fracture(s). Small pumping rate variations can occur during testing due to fluctuations in the rotational speed of the whale pump and small variations of 0.01-0.02 gpm may or may not be meaningful.

Fractures in OC-BB-1-2018, to the extent they are present, parallel bedding striking northeast, with steep dips to the northwest of 60 to 80 degrees.

Overall, the bedrock is competent and the observed fractures are well below the bottom of the DAPL in the Containment Area (**Cross Section A-A'**).

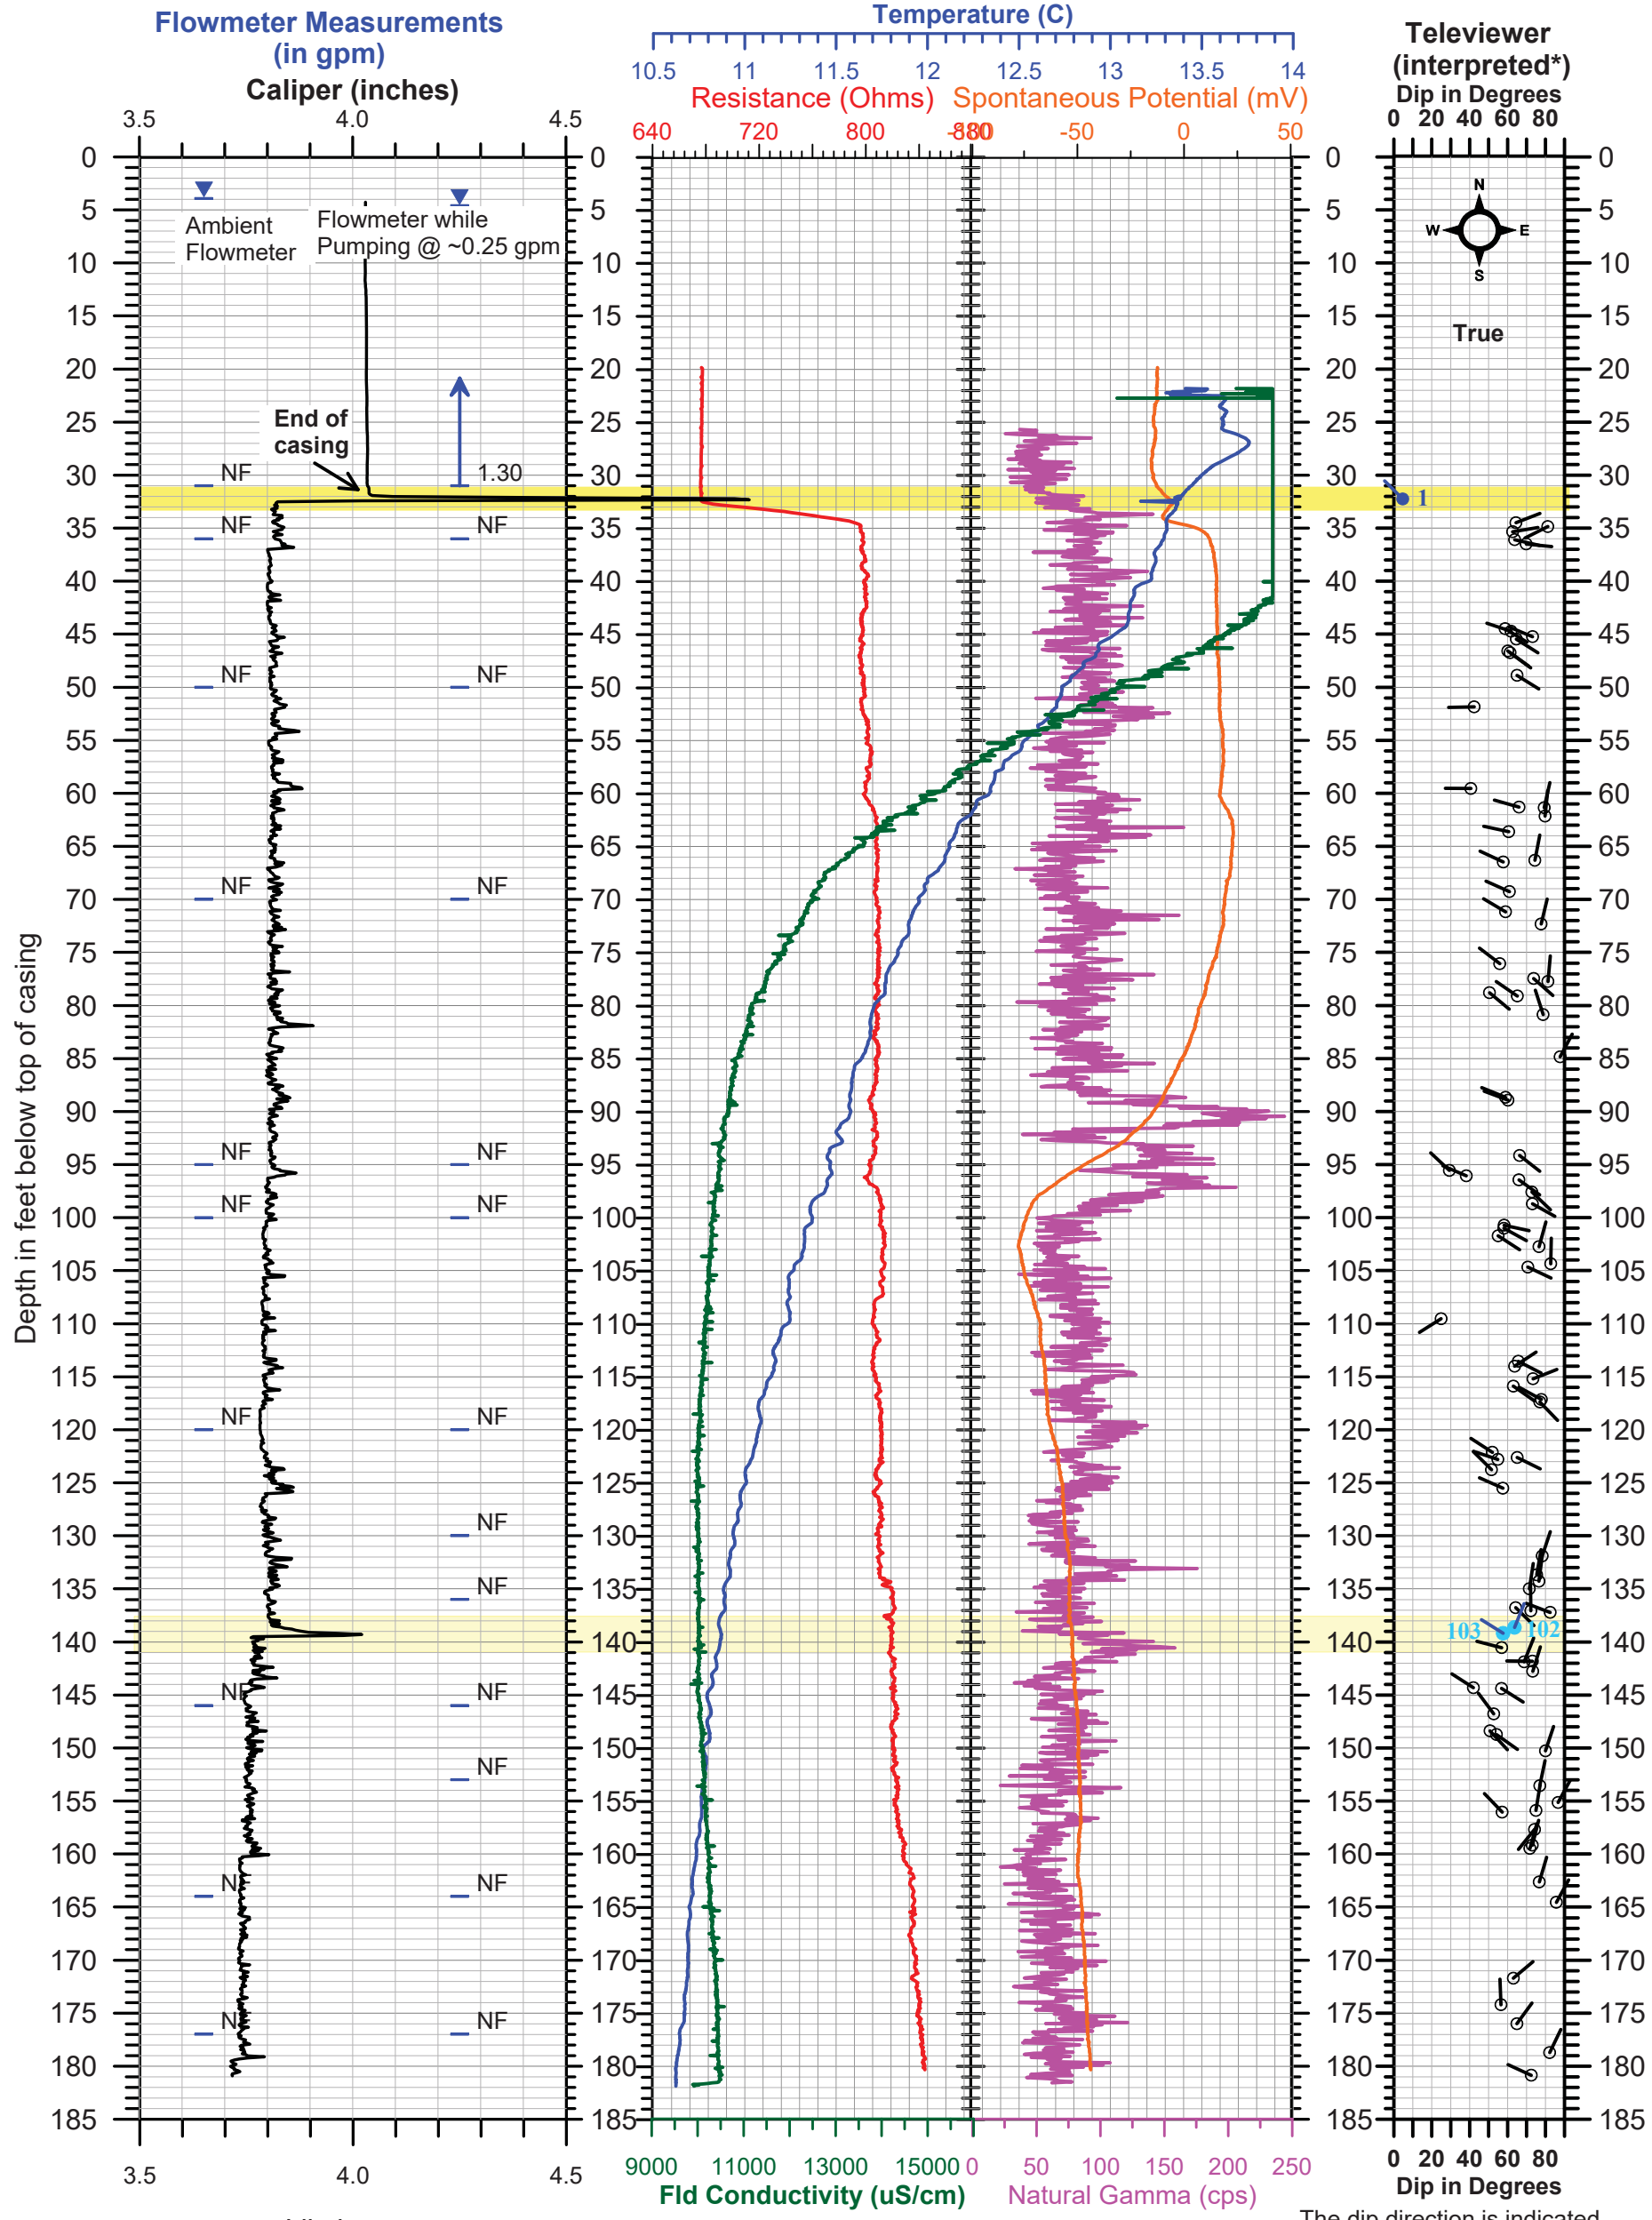
PLATE B-1  
Borehole Geophysical Log  
OC-BB-2-2018  
Olin Site  
Wilmington, MA.

The borehole geophysical results at OC-BB-2-2018 confirmed 150 feet of competent bedrock below minor seepage encountered at the bottom of the casing. The OTV log clearly shows the separation between the steel casing and the bedrock surface within the bedrock socket. Although the composite log correctly identifies this as a “likely transmissive zone”, it is not a fracture. The borehole logging identified only one potential “possible transmissive zone” related to fracturing and that is based solely on a caliper deviation at 140 feet bgs. There are no inflections in any other logs at this depth, no flow was measured with the HPFM from depths below 35 feet, and there were no obvious fractures present in the ATV amplitude log or the OTV log. The two borehole features at 140 feet bgs depth dip to the northwest and north-northeast at approximately 60 degrees. It is unlikely that this zone represents a transmissive fracture interval. In general it appears that bedrock in OC-BB-2-2018 is un-fractured and highly competent over the entire borehole.

Similar to OC-BB-1-2018, bedrock is competent in the vicinity and the observed fractures are well below the bottom of the DAPL in the Containment Area (**Cross Section B-B'**)
